Manhole Inspection Summary

Manhole # S67K__002MH

Insp Date: **3/1/08 1:51 PM**

Location Address: **912 Dundalk Ave.**

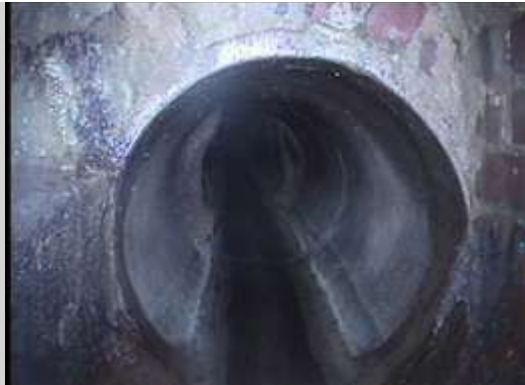
6 O'Clock Inflow

18 in. Circular Gravity Sewer
Pipe In @ 6 O'Clock

Pipe Height: **18** (in.) Rod and Bar (Angled)

Pipe Material: **Clay** ☐ Pipe Lined

Infiltration: **None** Pipe Seal Cond: **Sound**
